Development and Application of BEOL Polymer Residue Removal Technology

Abstract

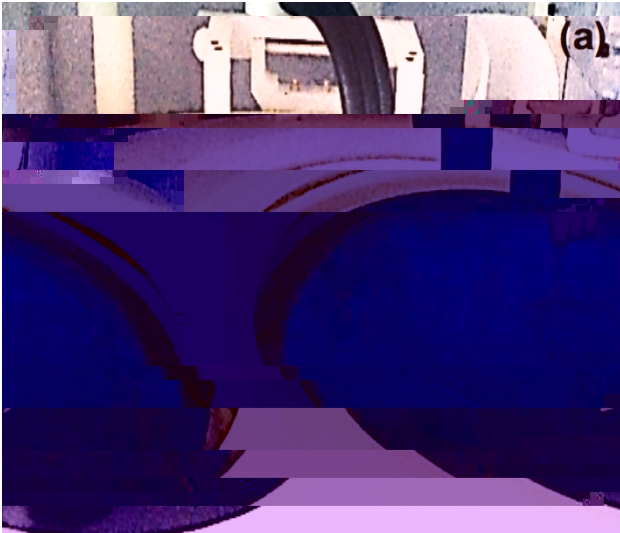
Fig. 6. (a) Captured image of ST250 layer thickness at a rotation rates of 400 rpm. (b) Water layer thickness profiles at the rotation rates of 200, 500 and 1400 rpm respectively [4].

Hitoshi et al. found that in single-wafer wet cleaner, the local thickness of water layer is related to various parameters, such as wafer rotation speed and radical distance from wafer center [4]. As shown in Fig. 6(b), at the rotation rates of 200, 500 and 1400 rpm, the water layer thickness does not present steady curves as the radical distance changes. At the radial distance from wafer center of around 10mm, both liquid layer thickness and the radical velocity are much smaller than other zones (radical velocity profile is not shown). We suspected that the combination of thinner liquid layer thickness and slower radical velocity will result in poor chemical wetting at this local area, which consequently results in ball-type defect deposition. This phenomenon is more pronounced to high-viscosity chemical, such as ST250. The captured image in Fig. 6(a) also confirms this prediction. As shown in Table 1, viscosity of ICS8000 is much lower than ST250's, which is the reason why ICS8000 does not suffer the ball-type defects (Fig. 5).
